# **ACE Consulting South West Ltd**

## **Demolition Asbestos Survey Of Dairy Building**

<b>Site Details including postcode</b>	Dairy Building		
<b>Survey Type</b>	Demolition Survey		
<b>Client Details</b>	Leader Development		
<b>Survey Date</b>	30 Sept 2024	<b>Report Date</b>	06 Oct 2024
<b>Job No.</b>		<b>Issue No:</b>	One
<b>Surveyor</b>	Andy Ellis C.M.I.O.S,H. CCP (Asbestos)		
<b>Area included within the survey</b>	Building		
<b>Areas Excluded from the survey</b>	Nil		
<b>Any agreed exclusions or inaccessible areas</b>	Below ground slab and surround

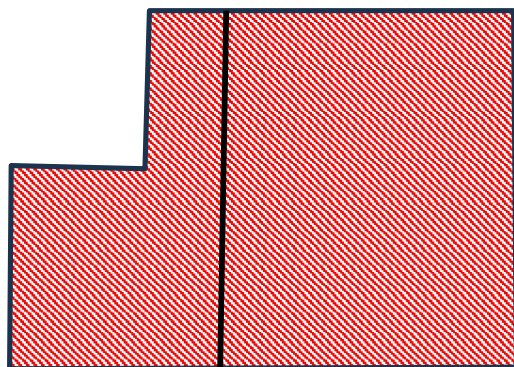
## Ground Floor

AE300924/01

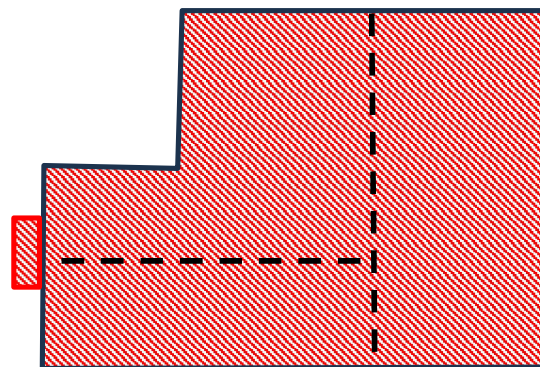
## External

AE300924/02

AE300924/03

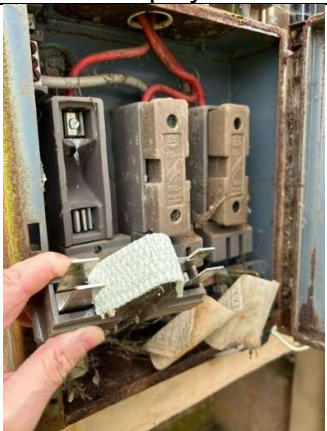
Photo 1 Fuse box external Textiles

The external fuse boxes has been found to contain asbestos textiles and the cartridge fuses strongly presumed to contain paper,

The Removal of the electrical items should be undertaken by a None licensed trained contractor with asbestos insurance and a Risk assessment and safe system of work, examples of such are on the HSE website, "Asbestos Essentials"

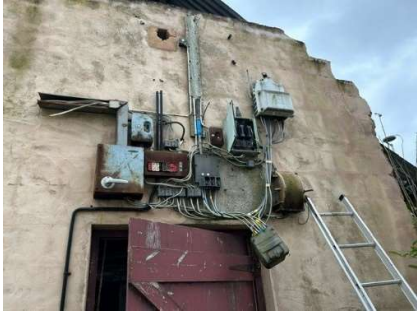
Photo 2 Main Building Room External Electrical equipment, only couple opened

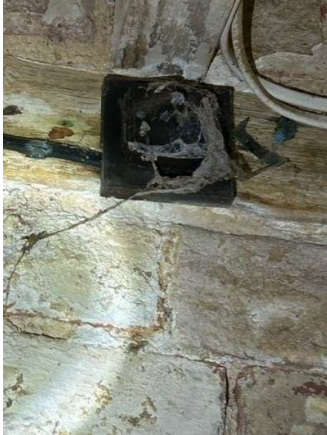
Photo 3 Main Building Ground Floor Room GF01 Bakelite electrical equipment

The Bakelite electrical fittings through out the property have been strongly presumed to contain Chrysotile (White) asbestos, they should be removed as asbestos containing and disposed of as Hazardous Waste,

The Removal of the Bakelite electrical Fittings should be undertaken by a None licensed trained contractor with asbestos insurance and a Risk assessment and safe system of work, examples of such are on the HSE website, "Asbestos Essentials"

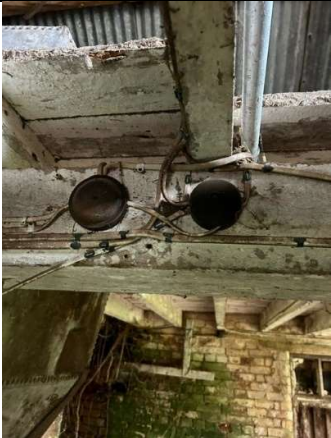
<p>Photo 4 Main Building Ground Floor Room GF02 Bakelite Electrical Fitting</p>

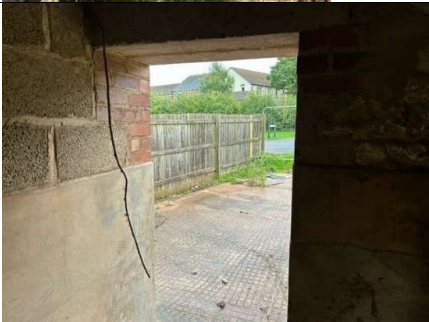
<p>Photo 5 Main Building Ground Floor Room GF02 Textile on Electrical cable</p>

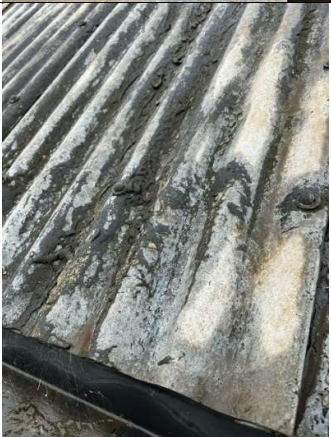
<p>Photo 6 Main Building Room External Bitumen paint to metal sheeting</p>

The metal roofing sheets throughout the roof has been identified as containing Chrysotile Asbestos. When the building is demolished the metal sheeting should be removed as asbestos containing and disposed of as Hazardous Waste.

The Removal of the roof should be undertaken by a None licensed trained contractor with asbestos insurance and a Risk assessment and safe system of work, examples of such are on the HSE website, "Asbestos Essentials"

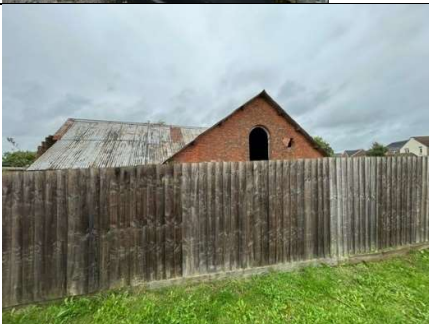
<p>Photo 7 Main Building External, building</p>
